Testing and Evaluation of the

W-Beam Transition (On Steel Posts

With Timber Blockouts) to the

Vertical Flared Back Concrete

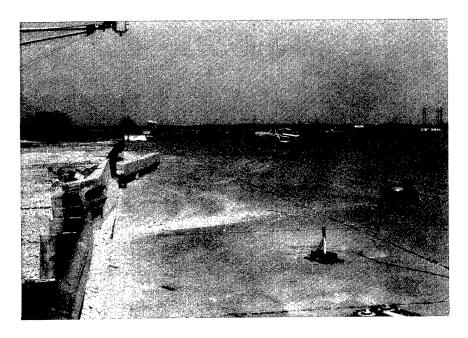
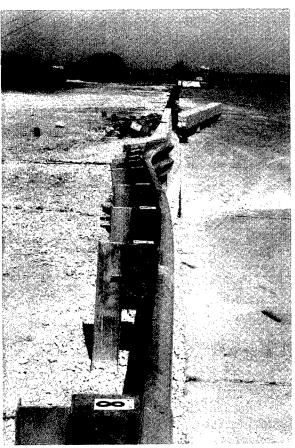
Figure 10. After impact trajectory for test 405491-2.

The W-beam transition (on steel posts with timber blockouts) to the vertical flared back concrete bridge parapet contained and redirected the vehicle through controlled lateral deflection. The vehicle did not penetrate or go over nor under the transition. However, there was some snagging of the vehicle as it impacted the end of the concrete parapet wall. There were no detached elements or debris to show potential for penetrating the occupant compartment or to present undue hazard to others in the area. Occupant deformations from the initial impact were moderate and may not have caused serious injury. However, deformations which occurred from the rollover after the vehicle exited the installation may have caused serious injury. The vehicle remained upright during the collision and then rolled 360 degrees upon exiting the test installation. The vehicle yawed and then rolled into the adjacent traffic lanes. The occupant risk factors were within the limits specified in NCHRP 350. The exit angle at loss of contact was 18.5 degrees, which was greater than 60 percent of the test impact angle.

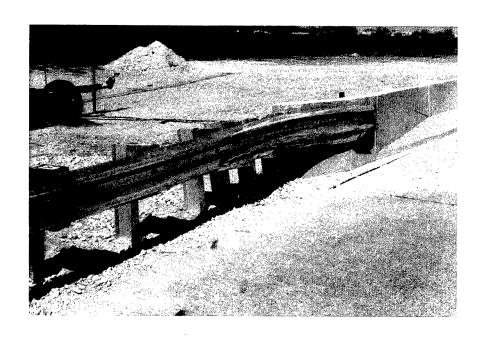
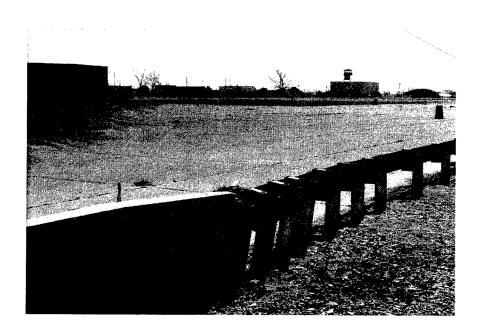
Figure 11. Transition after test 405491-2.

Damage to the installation is shown in figures 10 through 13. Posts 6 through 1 were pushed back 10 mm, 35 mm, 85 mm, 125 mm, 160 mm, and 140 mm, respectively. The timber blockouts were damaged as shown in figure 12. There were tire marks on the face of the W-beam rail element and on the concrete parapet (see figure 13). There were shear cracks in the parapet and the parapet was pushed away from the bridge deck 35 mm, as can be seen in figure 13. Total length of contact of the vehicle with the installation was 4.1 m.

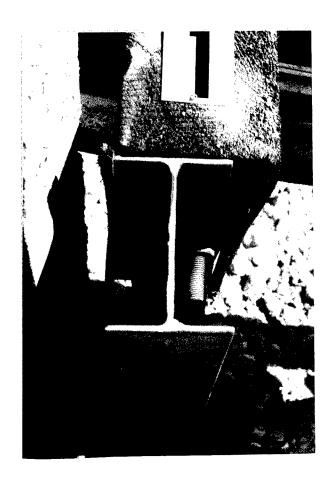
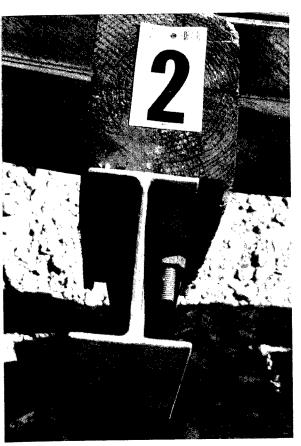
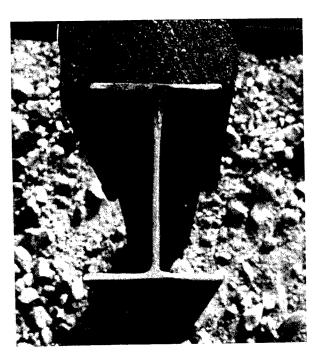
Figure 12. Damage to blockouts at posts 1 through 3 after test 405491-2.

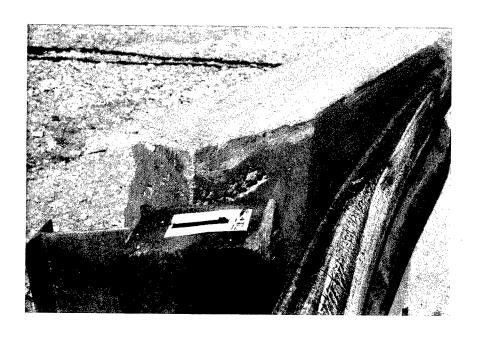
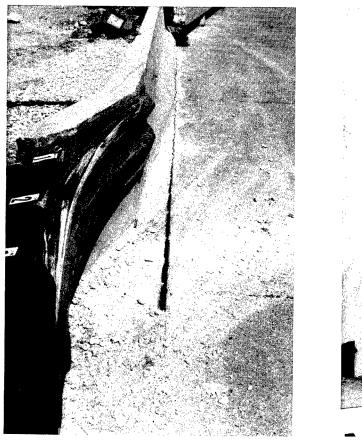
Figure 13. Damage to concrete parapet after test 405491-2.

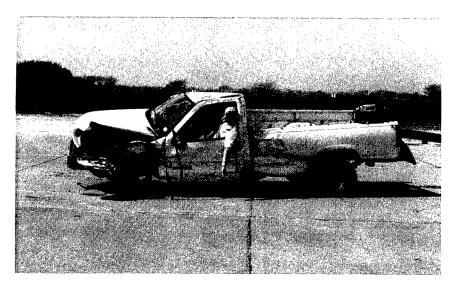
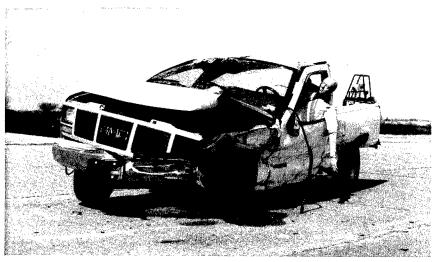
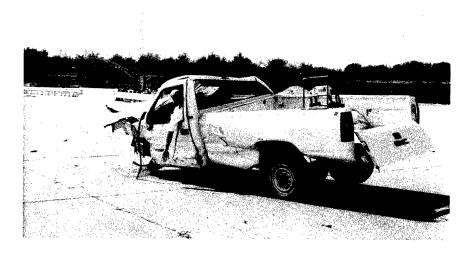
The vehicle received extensive damage as shown in figure 14. Damage to the left front wheel assembly included the upper and lower A-arms, tie rods, stabilizer bar, pitman arm, and steering box, and the tire, wheel and spindle were torn from the vehicle. The frame was bent and the floorpan was buckled. The front bumper, hood, grill, fan, radiator, left front quarter panel, left door, left side of the bed, and left tire and rim were also damaged. The roof, windshield, both door windows, and the right side of the vehicle were damaged during the rollover.

Figure 14. Vehicle after test 405491-2.
